Welsh Wreck Web Research Project (North Cardigan Bay)

‘GLENOCUM’ *formerly known as the* ***‘TORCA’***

The wreck of the steamship ‘Glenocum’, stranded in Aberdaron Bay, North Wales, in May and June, 1883.

GLENOCUM

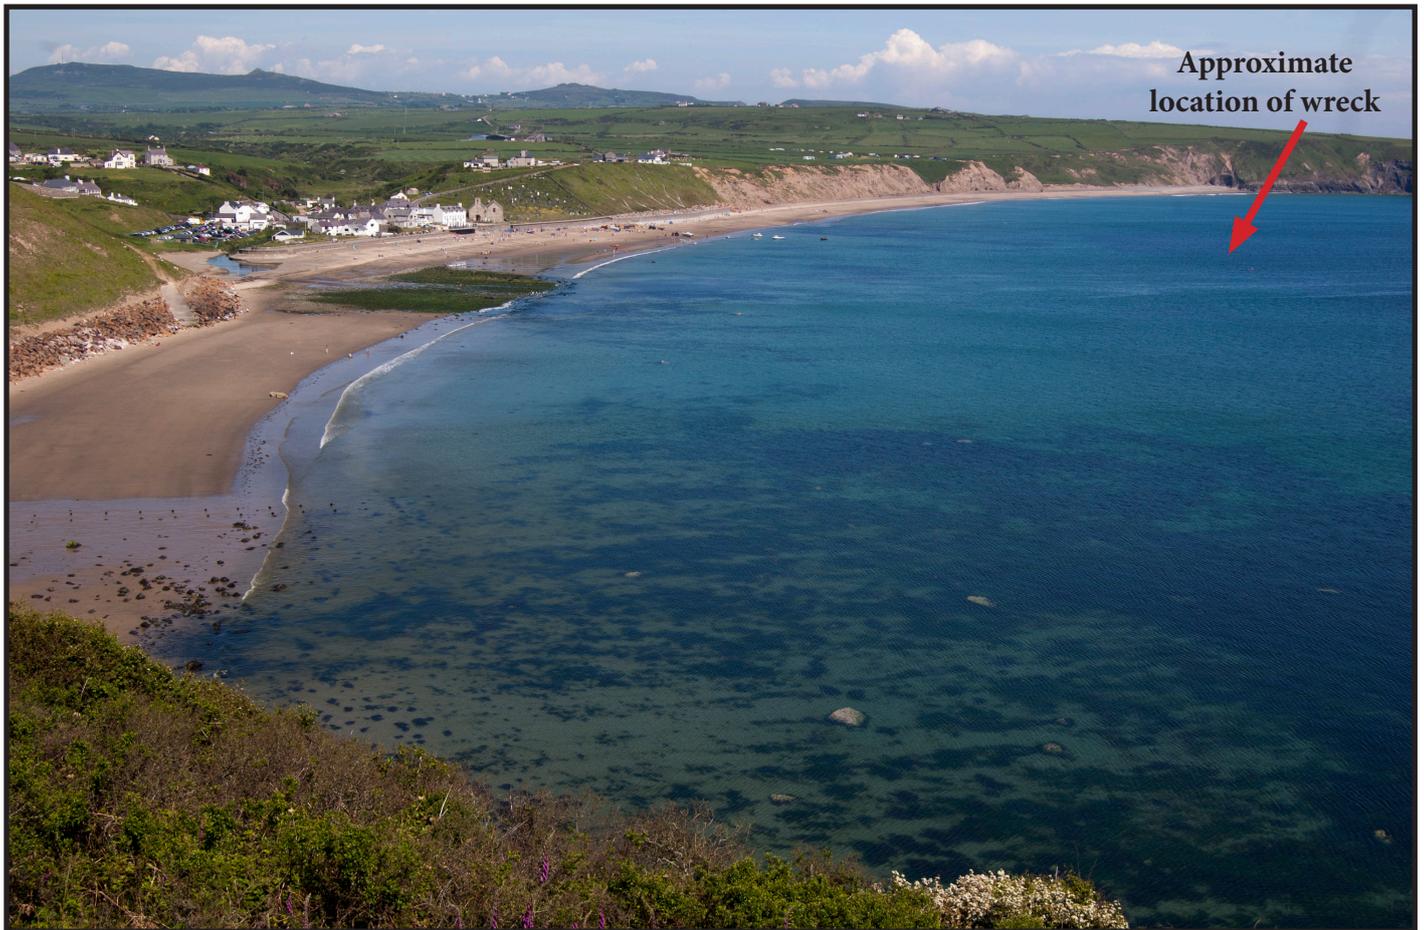
Aberdaron Bay, showing the location of the wreck of the ‘Glenocum’.

This report describes the remains of the 3-masted, iron steamer ‘Glenocum’ which initially ran ashore near Maen Gwenonwy in 1883 during thick fog. She was subsequently re-floated but had to be beached in Aberdaron Bay. Built in 1875 at the shipyard of T. Grendon & Co., Drogheda, Ireland, and originally named ‘Torca’, the ‘Glenocum’ was owned by The Belfast Steamship Company and propelled by a 75-horsepower, 2-cylinder steam-engine. According to the 1881 edition of Lloyd’s Register, the Glenocum was 146 feet 5 inches long, with a beam of 22 feet 4 inches. Having measured this wreck from the prominent bow to the stern-post, I came to a total of 147 feet 8 inches which, allowing for minor errors, is virtually the same as the ‘Glenocum’.

Lloyd’s List of 25th May, 1883, reported that the ‘Glenocum’ was ashore and full of water. By the 28th, the Liverpool Salvage Association had re-floated the ship, but then had to beach her again at Aberdaron in the hope of removing the cargo and repairing the ship. Operations continued all summer to recover most of the cargo of iron bars, along with the ship’s anchors, chains and fittings. By September 20th, 246 tons of cargo had been removed, but all hope of saving the ship had been lost and work was abandoned, so the wreck and remaining fittings were sold for £70.

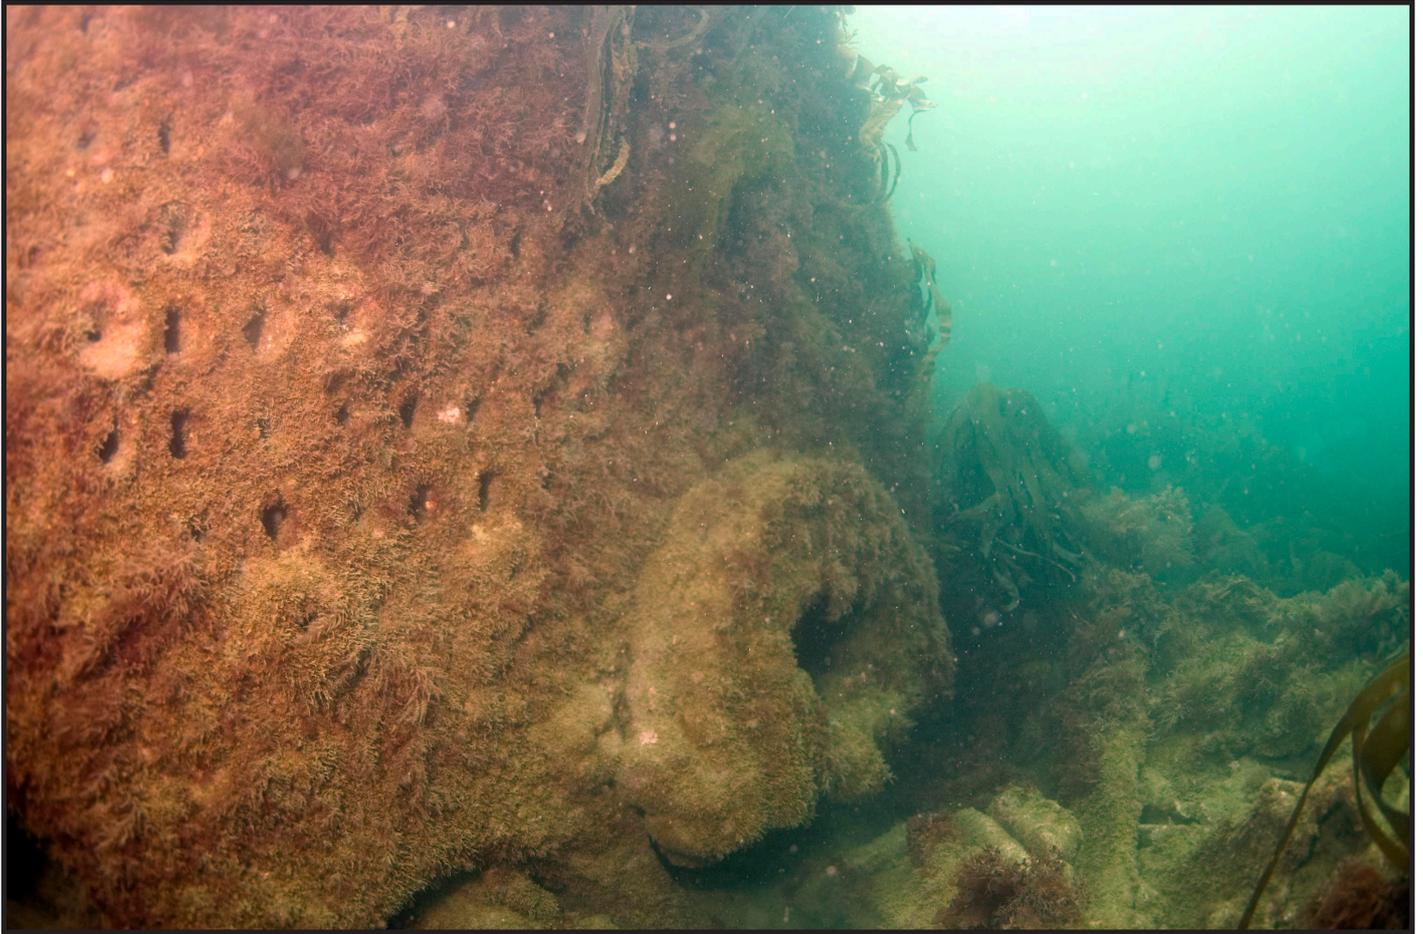
The boiler of the ‘Glenocum’.

wreck, where even at high-water the maximum depth will be less than 10 metres. The deck is completely missing, so there are no passageways or holds to explore other than the fore-peak, but the single 4-metre high ‘Scotch’ (tubular) boiler remains upright and intact, with dense kelp growing on its upper surface, and tompot blennies and leopard-spotted gobies peering out of the pipes emerging from the vertical faces of the boiler. The twin furnaces face towards the stern, a design feature of a small vessel in which the jobs of engineer and stoker could be combined.

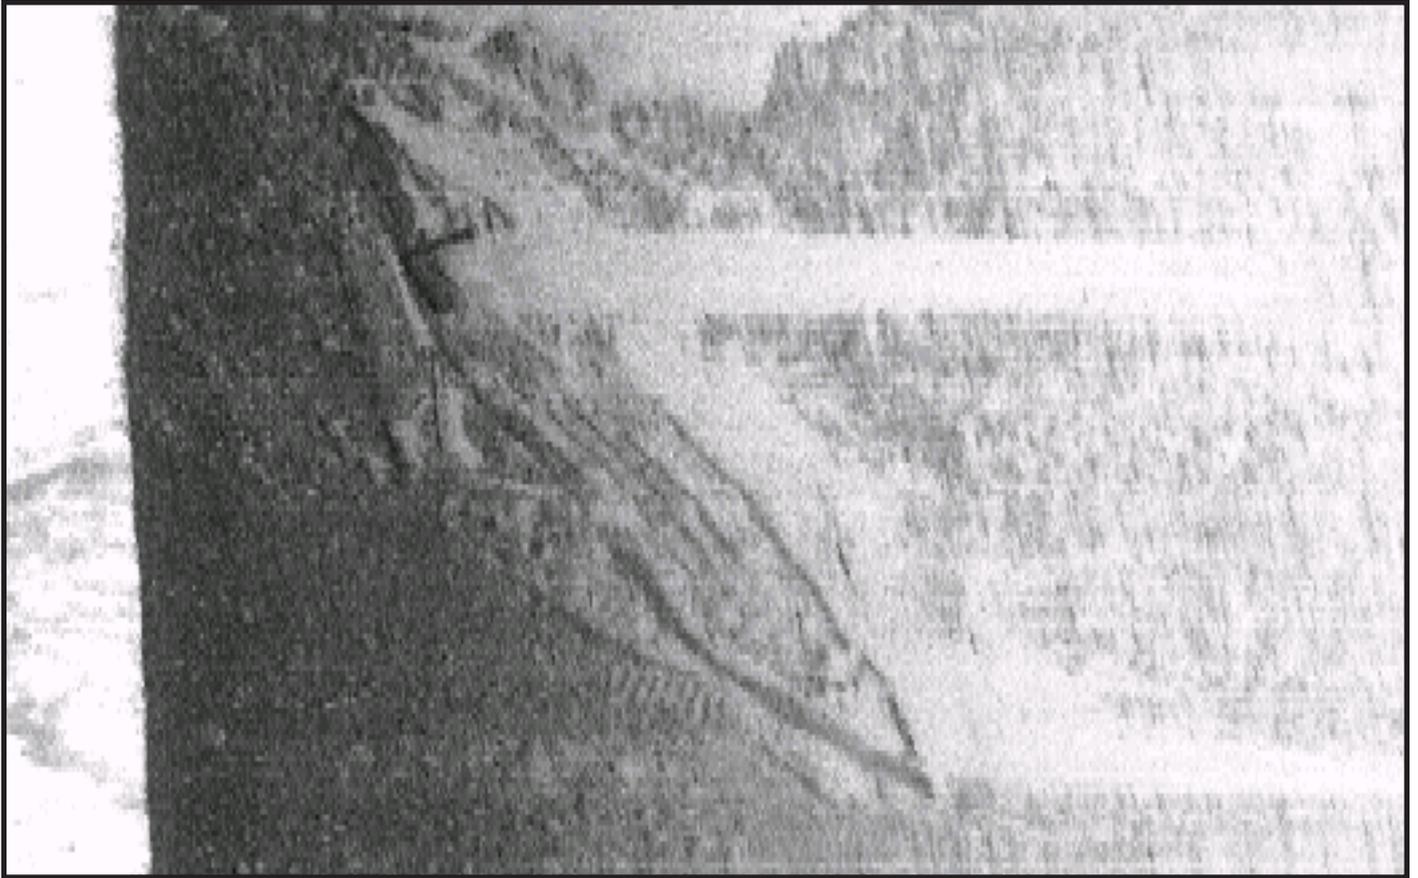
An side-scan trace of the wreck

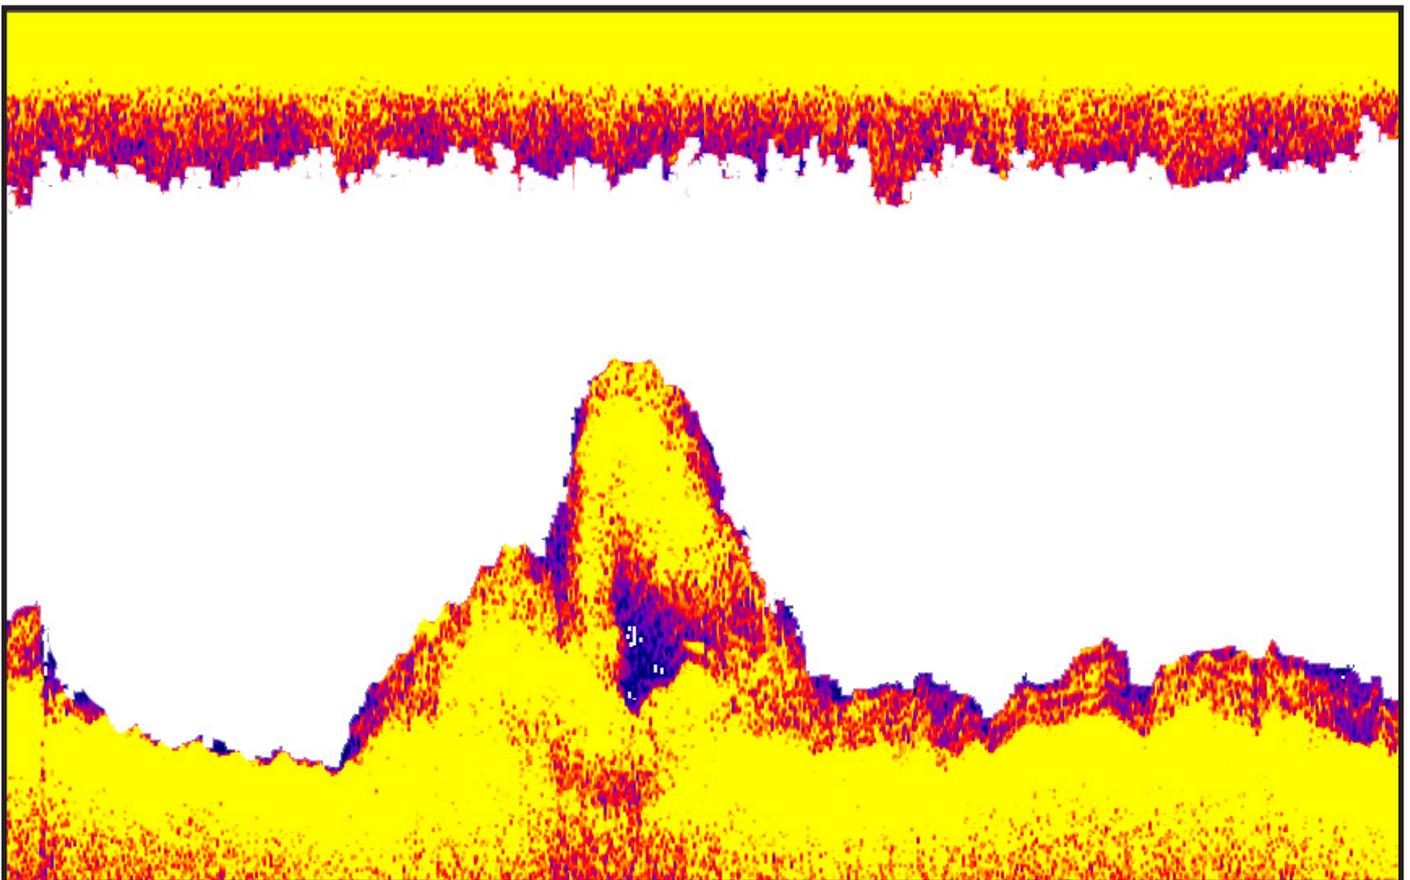
An echo-sounder trace of the wreck

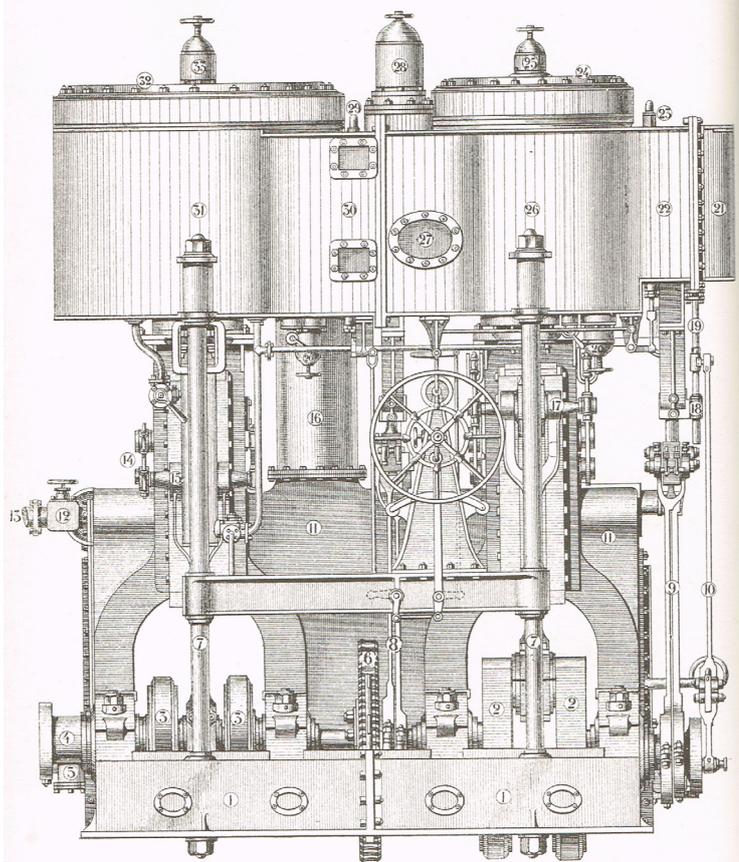
PLATE 49.

It is assumed that the engine of the 'Glenocum' was recovered by the salvors during the 1880s.
