**Welsh Wreck Web Research Project
(North Cardigan Bay)
On-line research into the wreck of the:
*SS Duncan***

Nigel Cossons

March 2021

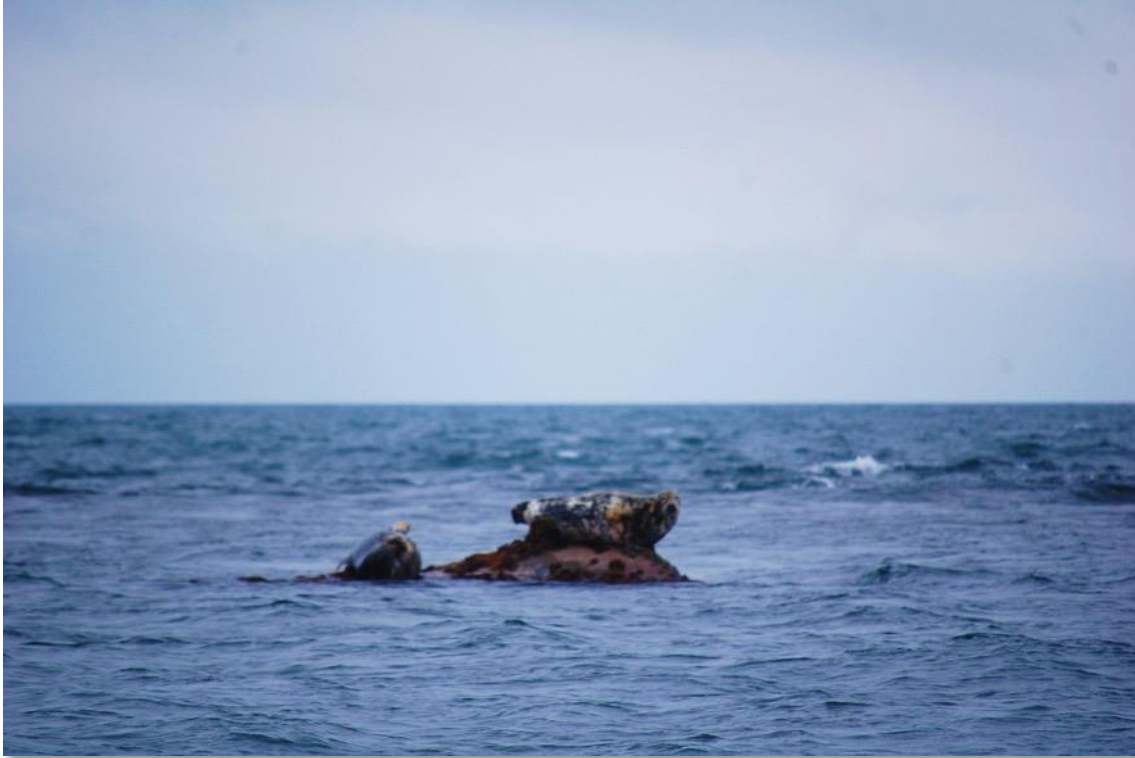
Figure 6.5 Seal on boiler at low tide (Source: C Holden)

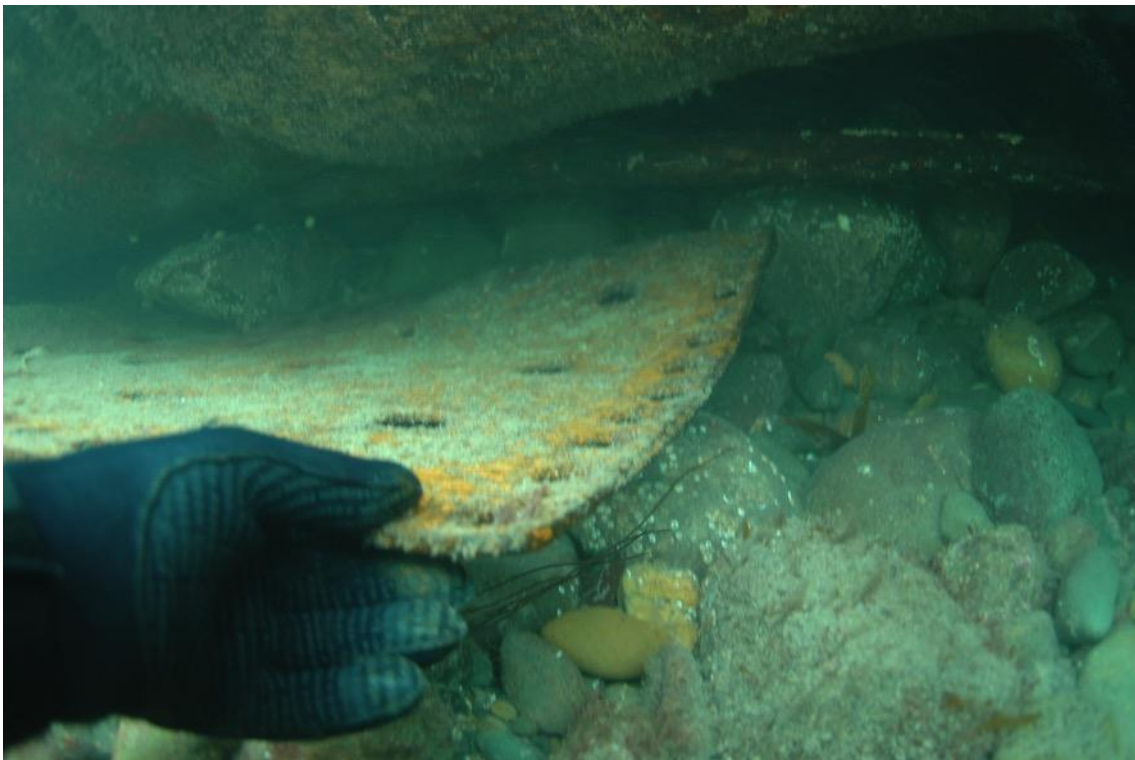
Figure 6.6 Plate close to boiler (Source: C. Holden)

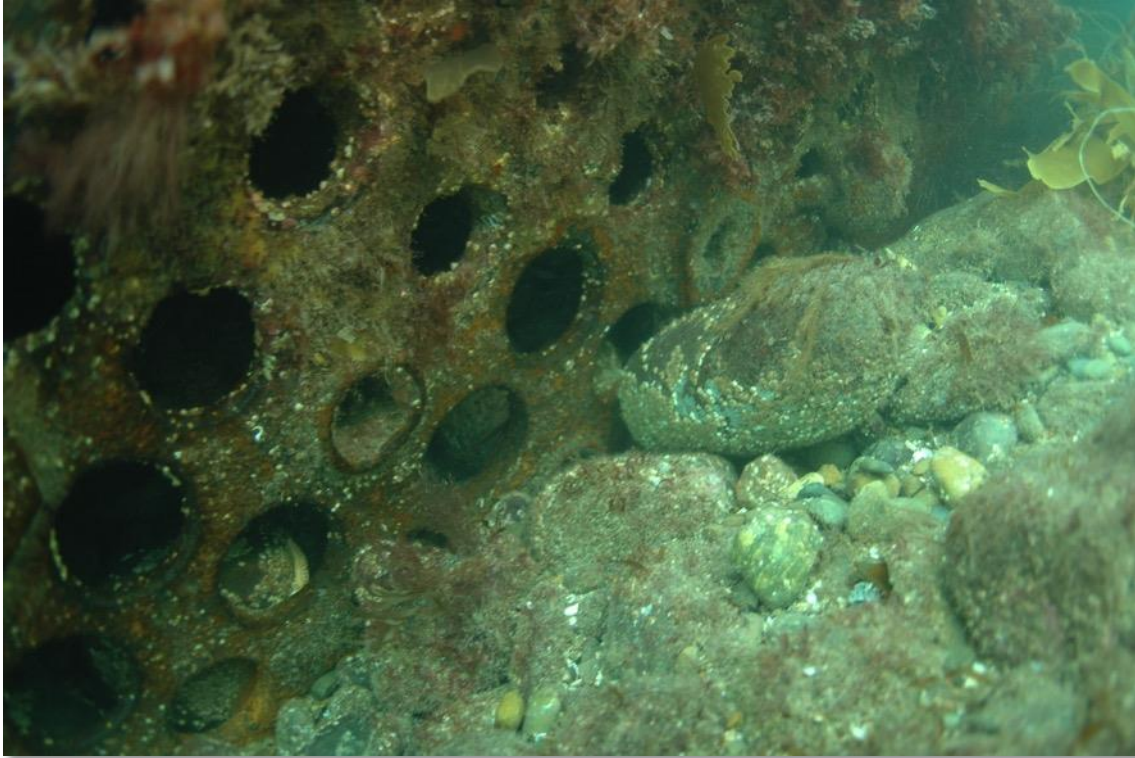
Figure 6.7 Boiler tubes (Source: C. Holden)

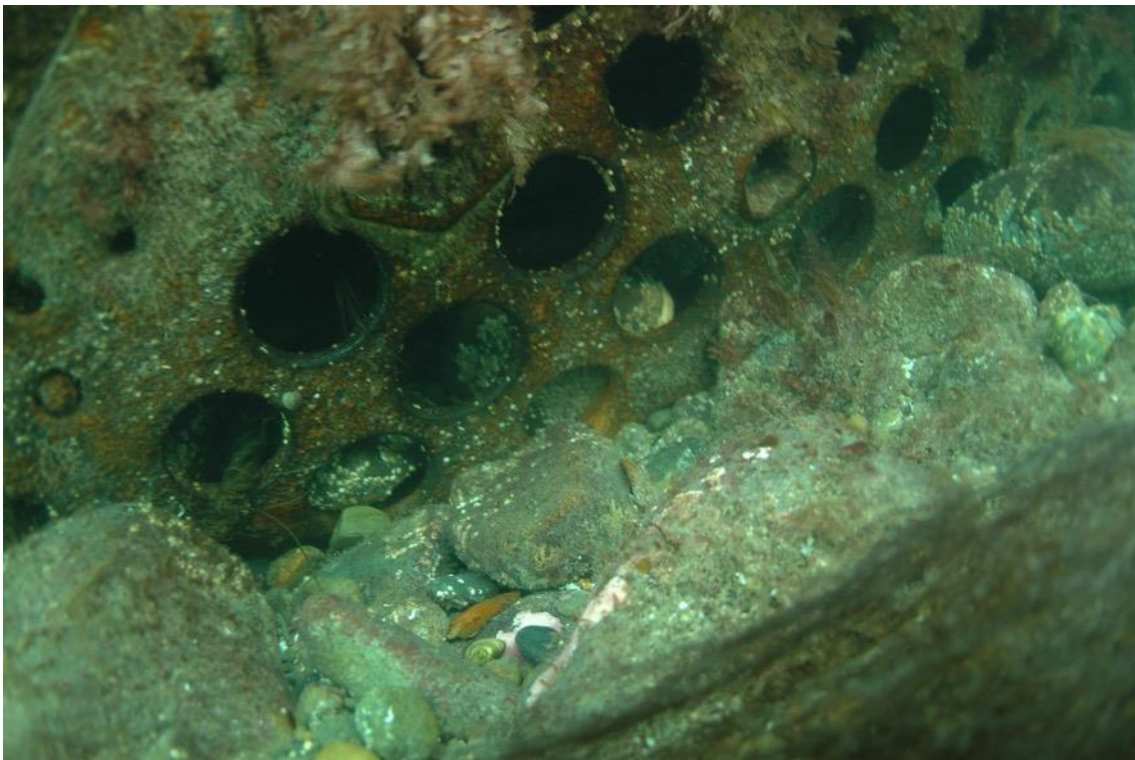
Figure 6.8 Boiler tubes (Source: C. Holden)

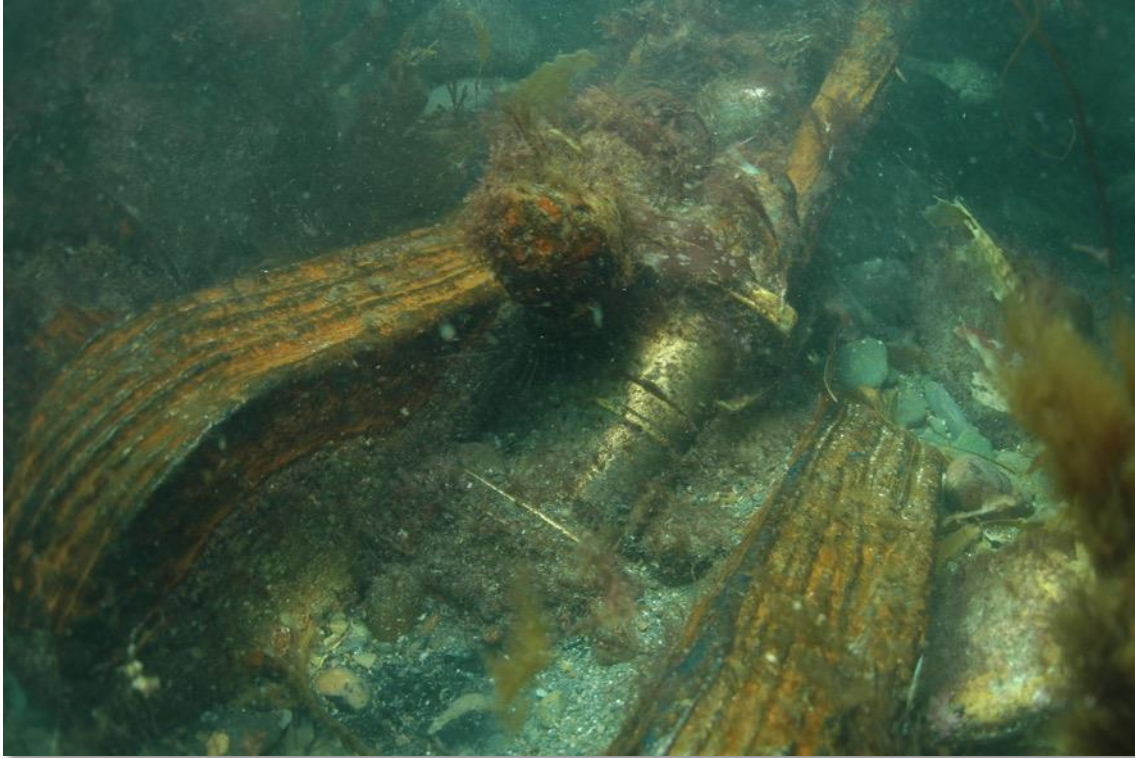
Figure 6.9 Crankshaft and brass fitting (Source: C Holden)

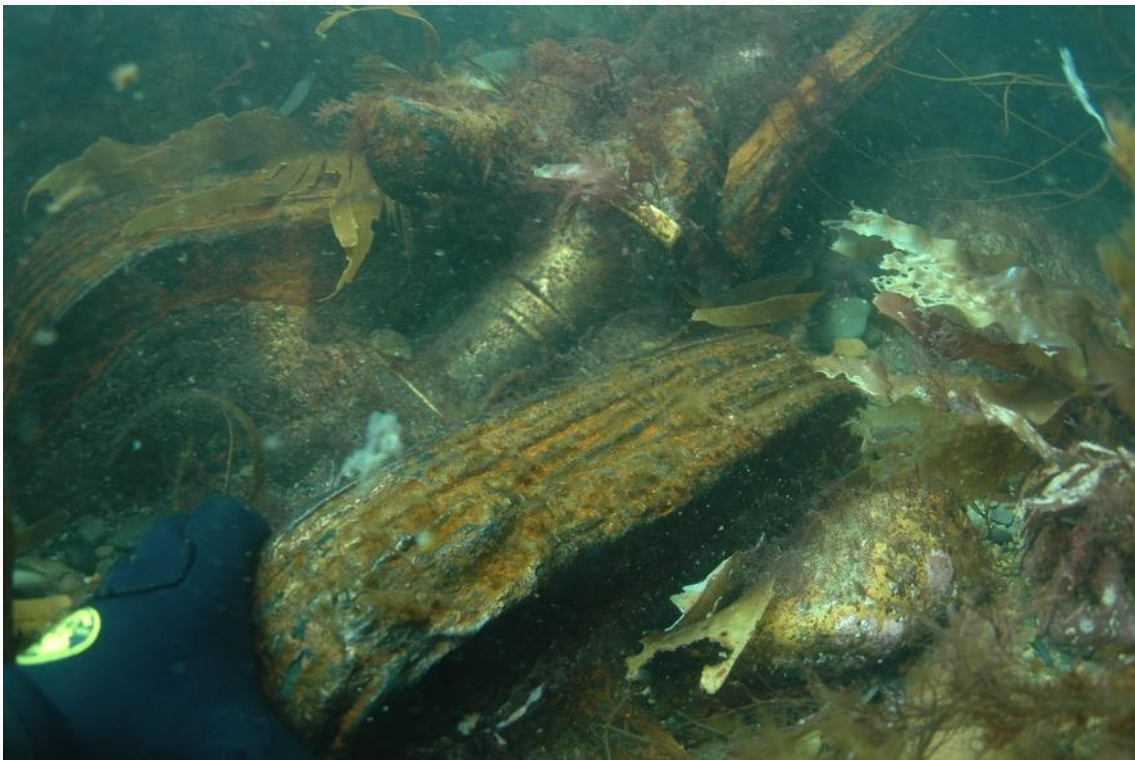
Figure 6.10 Crankshaft web (Source: C. Holden)

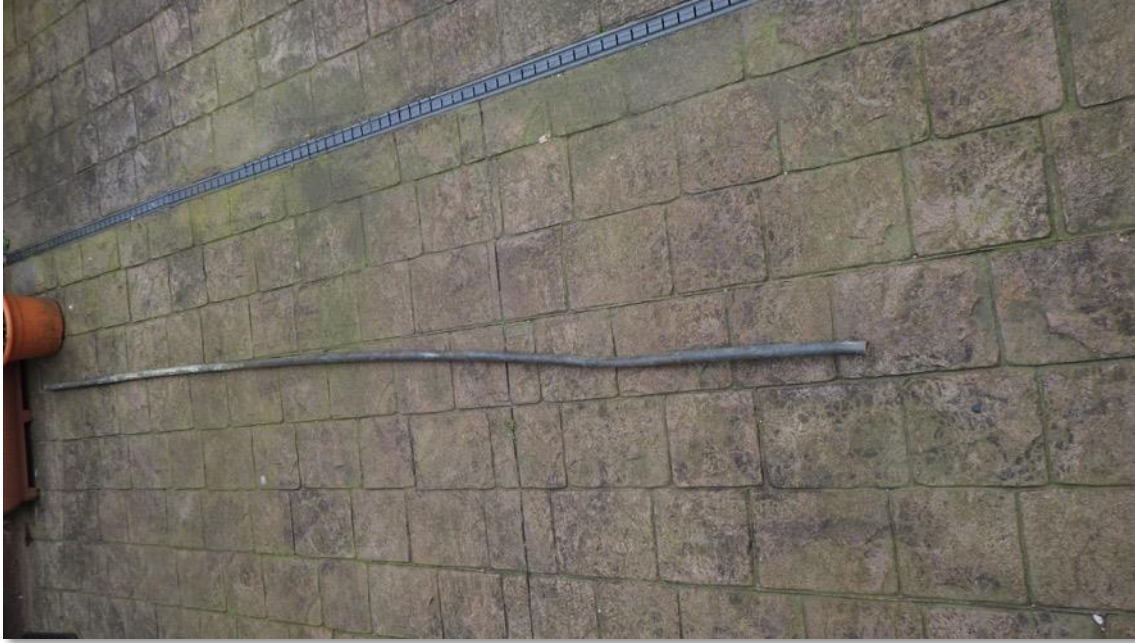
Figure 6.11 Probable brass condenser tube 240 cm x 2 cm (Source: C Holden)
