**Welsh Wreck Web Research Project
(North Cardigan Bay)**

Thora

**Welsh Wreck Web Research Project
(North Cardigan Bay)
On-line research into the wreck of the:
*Thora***

24 May 2020

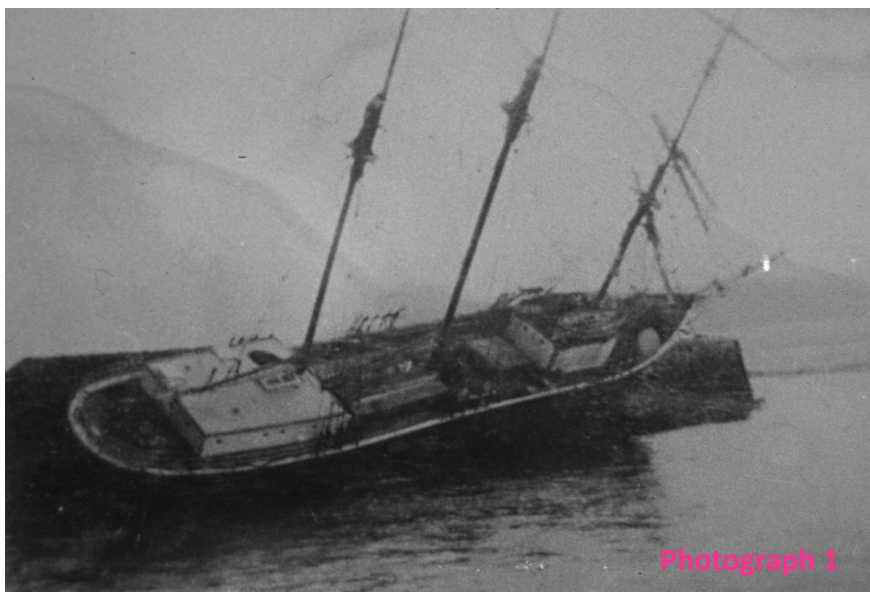
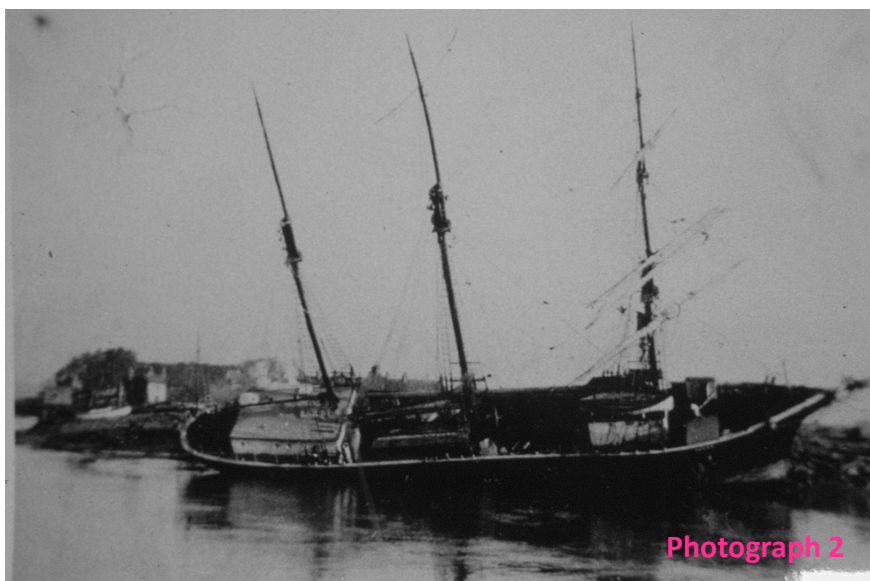
Photographic evidence of the incident does exist photograph 1 and 2 clearly show 'Thora' on the harbour wall at Portmadoc:

Both of these photographs clearly demonstrate the precarious position the vessel was in. Photograph 2 seems to show the hull twisted, which may be argued to be an indication of what follows.

It was in this year that she was lost. On the 29th October¹² she was stranded on the harbour wall at Portmadoc having been caught in strong winds and tides on arrival^{8, 9}. The images of her stranded on the harbour wall (Photographs 1 & 2) clearly show the precarious position She was in. Close inspection of Photograph 2 is suggestive of a twist in the shape of the hull and may possibly represent visual evidence that Her back had been broken. Photographs 10, 11, and 12, taken in 2014 show the keel broken in section, however without survey data it is impossible to speculate as to where on the vessel these sections of the keel are in the structure. Also from these photographs it was not possible to see where the mast steps were situated.

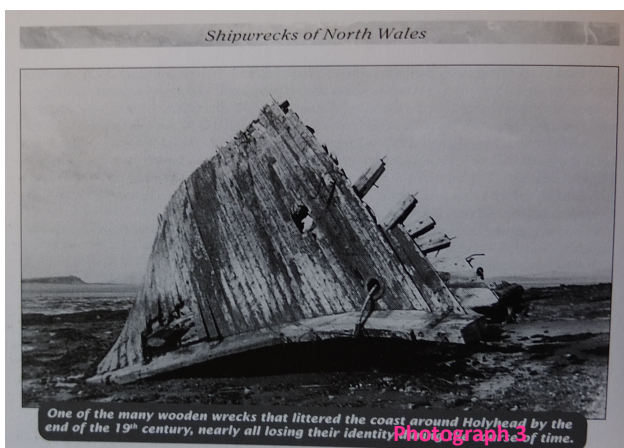
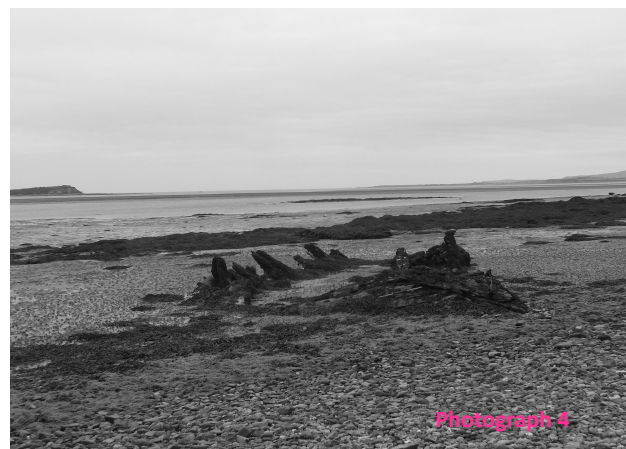
Photograph 3 shows the hull largely intact on the shore, at Holyhead. This photograph was attached to the email sent by Mr. Cave (Appendices F). Next to it is photograph 4, taken in 2014, showing the same view.

As per the image in photograph 4, today the site is very broken up but from the photographic evidence, taken during the 2014 field school there are still some intriguing features that are, arguably peculiar to this vessel.

The third aim of this report was to tie the photographs taken as part of the 2014 NAS field school into the story of the 'Thora'. Clearly Photographs 3 & 4 show the vessel as it was soon after Her abandonment alongside a contemporary view as direct comparison. There is evidence which is suggestive of the vessel did break it's back as seen in Photographs 10, 11 & 12, which is in-keeping with the narrative of the 'Thora'. However the most compelling photographs are those of the stern section of the vessel as marked in Fig. 2. These images show that despite the engine being removed in 1922 features of this survived in the fabric of the vessel, with the stern being covered over rather than re-built.

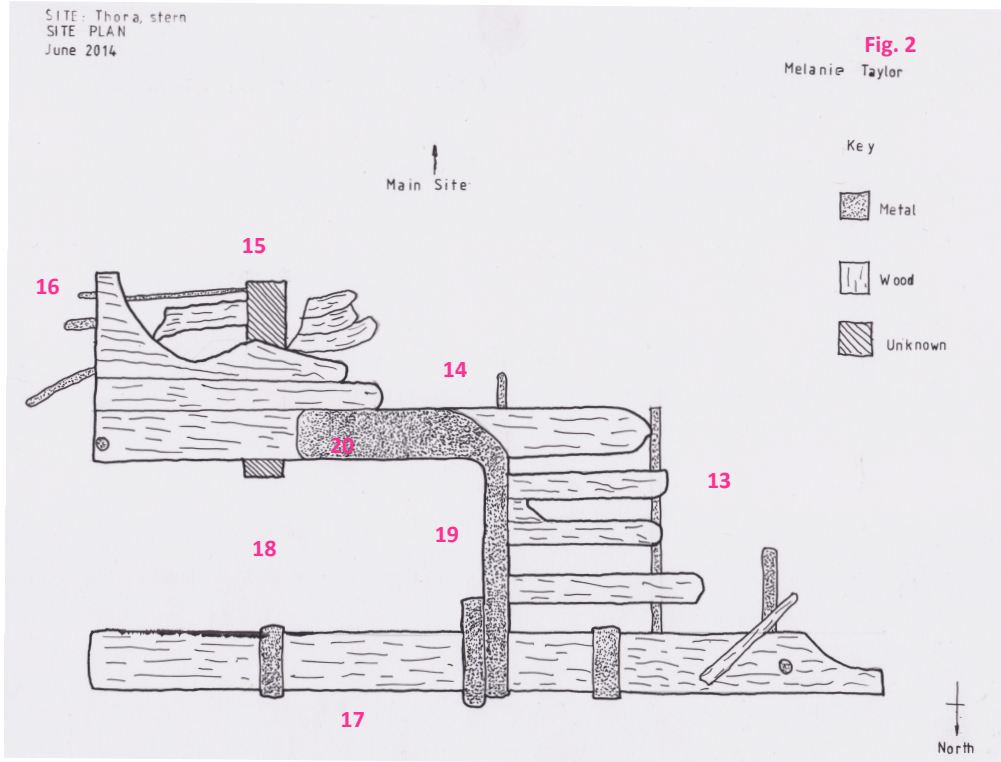
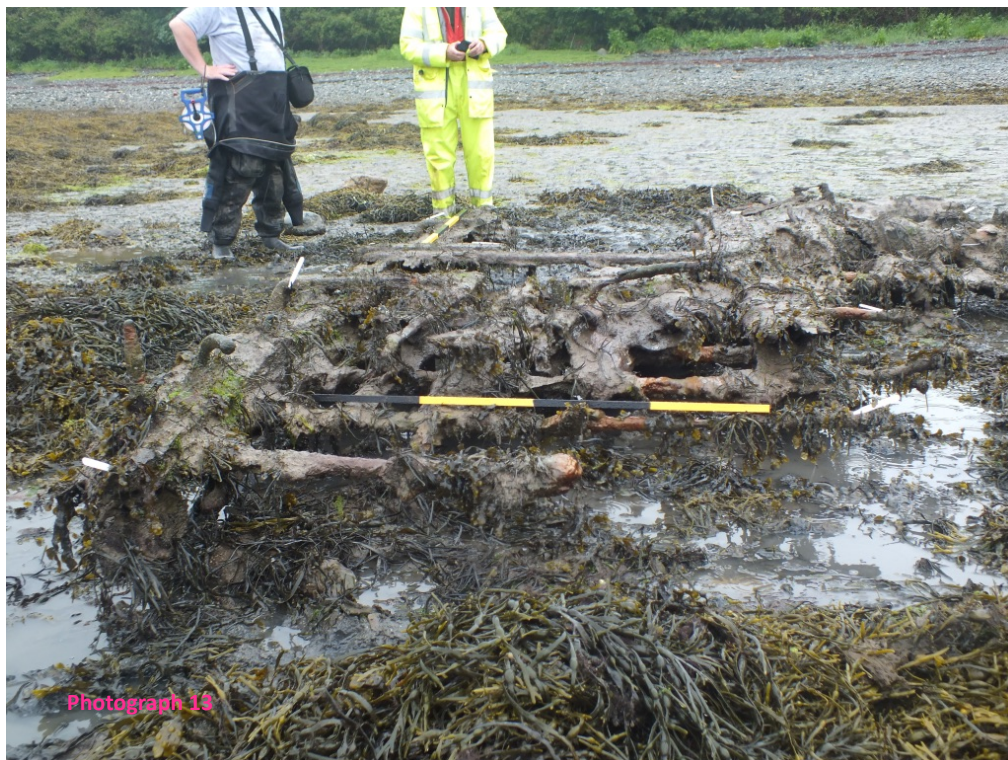
The main site, however is arguably not the most significant set of features of the 'Thora'. A short distance away from the main site was another section, the stern, the plan of which can be seen below (Fig. 2). This will be shown in conjunction with corresponding photographs of specific features.

Following her stranding she was soon placed for sale by her owners^{10, 11}, suggesting that the damage done would be far in excess of Her profitability. She was sold, according to Beth Cluer (Appendices G) to a Mr Davies, who made the models which are now situated at Plas Tan y Bwlch. In this source it suggests that the salvageable fittings, including masts, cables, anchors, etc., were removed and sold separately and that the hull was sold to a Mr Nunn and Family, coal merchants from Holyhead (Appendices F). It is on arrival at this location that the level of damage is determined, suggesting that Mr. Nunn was perhaps not entirely in the picture as to the amount of damage, and she had to be scrapped. Seemingly she was sold on to another buyer who had her dragged up to her present location and broke her up for firewood. Photograph 3, date unknown, shows the bow of the hull remaining upright in the position she was dragged to whilst Photograph 4 shows the condition of the remains bow in 2014. These two images mark the passage of time and the degrading of the timbers. Fig. 1 shows the plan of the main sited the structures that remained visible in 2014. It is important to note that there was no excavation work undertaken on the 2014 field school, this was simply an exercise in survey techniques. More of the structure may remain underneath the mud. What can be said is that both Fig. 1 and Fig.2

show structure that has been more or less undisturbed since being abandoned and the distance between the two sites is indicative of Her overall length.

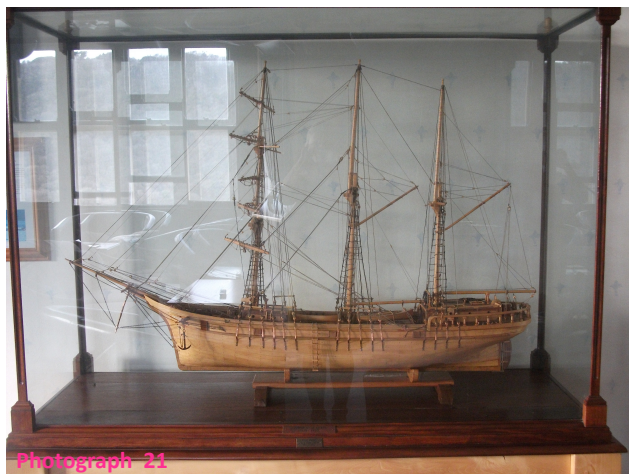
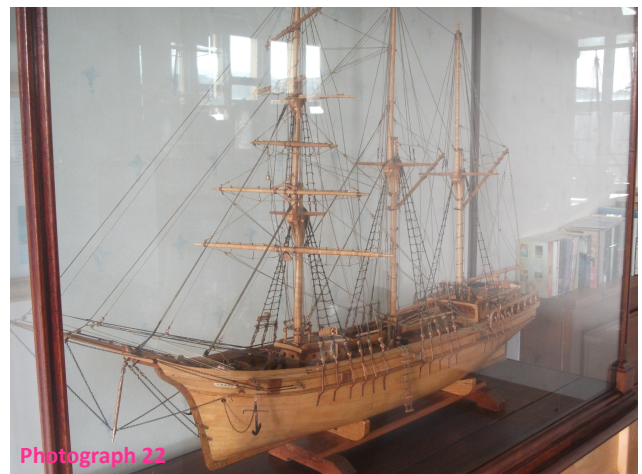
Through contact with Beth Cluer (Appendices G) we were also supplied to two photographs (21 and 22) of a model of the 'Thora' built by Mr Davies, which is located at Plas Tan y Bwlch, Blaenau Ffestiniog.
