Welsh Wreck Web Research Project (North Cardigan Bay)

On-line research into the wreck of the *Prince of Wales*

Prince of Wales Tragedy, 1966

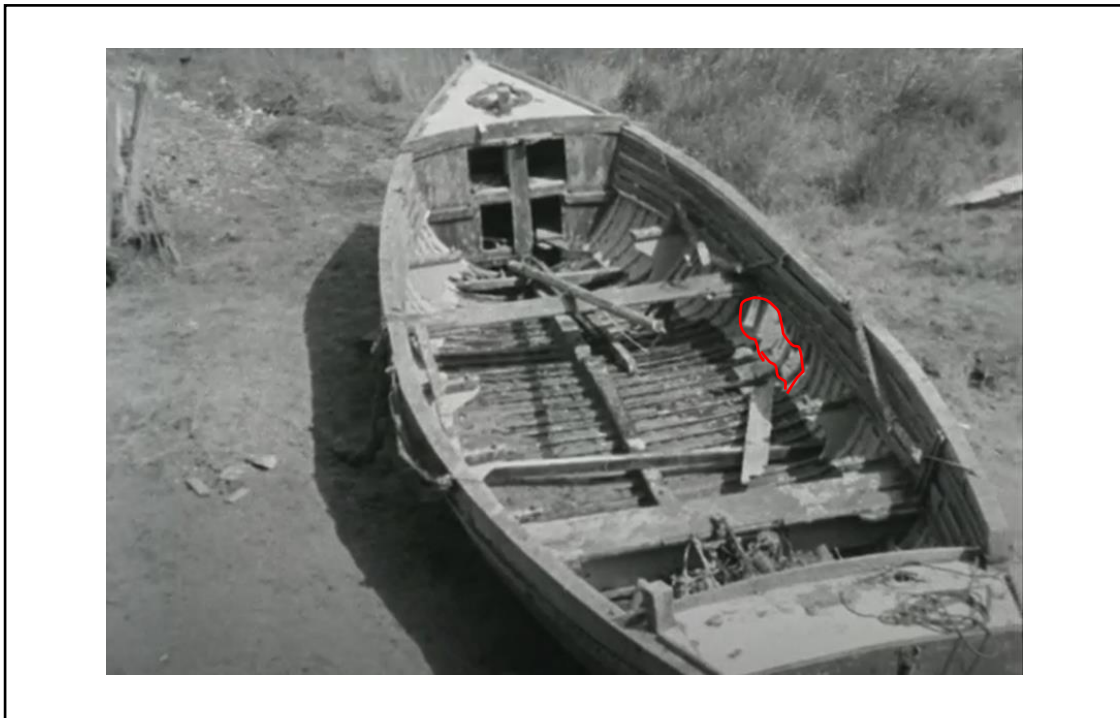
Wreck of the Prince of Wales (hole edged in red)

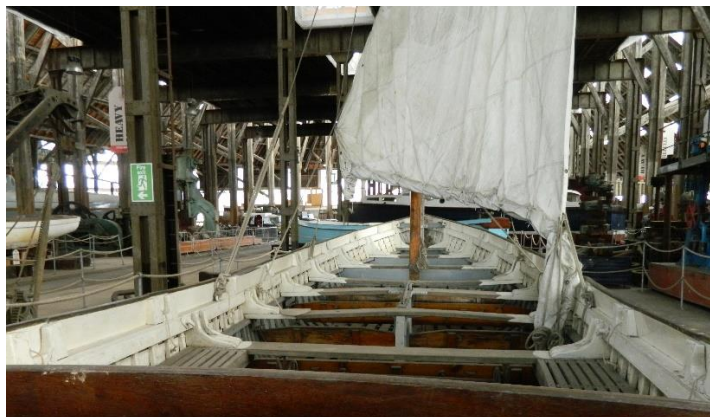
As the writer was keen to see how big (or small) a 32ft ex-naval cutter would be, a visit was undertaken to the Chatham Historic Dockyard in August 2021. Fig. 6 shows a 32ft cutter in sail configuration from the stern. It is hard to imagine 42 men, women and children, and Mr Jones packed into this boat.

Figure 6: 32ft cutter, built 1964 at Devonport (SHP075)
